REPORT NO. EVT 42-87

HEMTT SLING ANGLE FOR THE DOUBLE
BASKET CHAIN SLING

EVALUATION DIVISION
SAVANNA, ILLINOIS 61074-9639

US ARMY DEFENSE AMMUNITION
CENTER AND SCHOOL

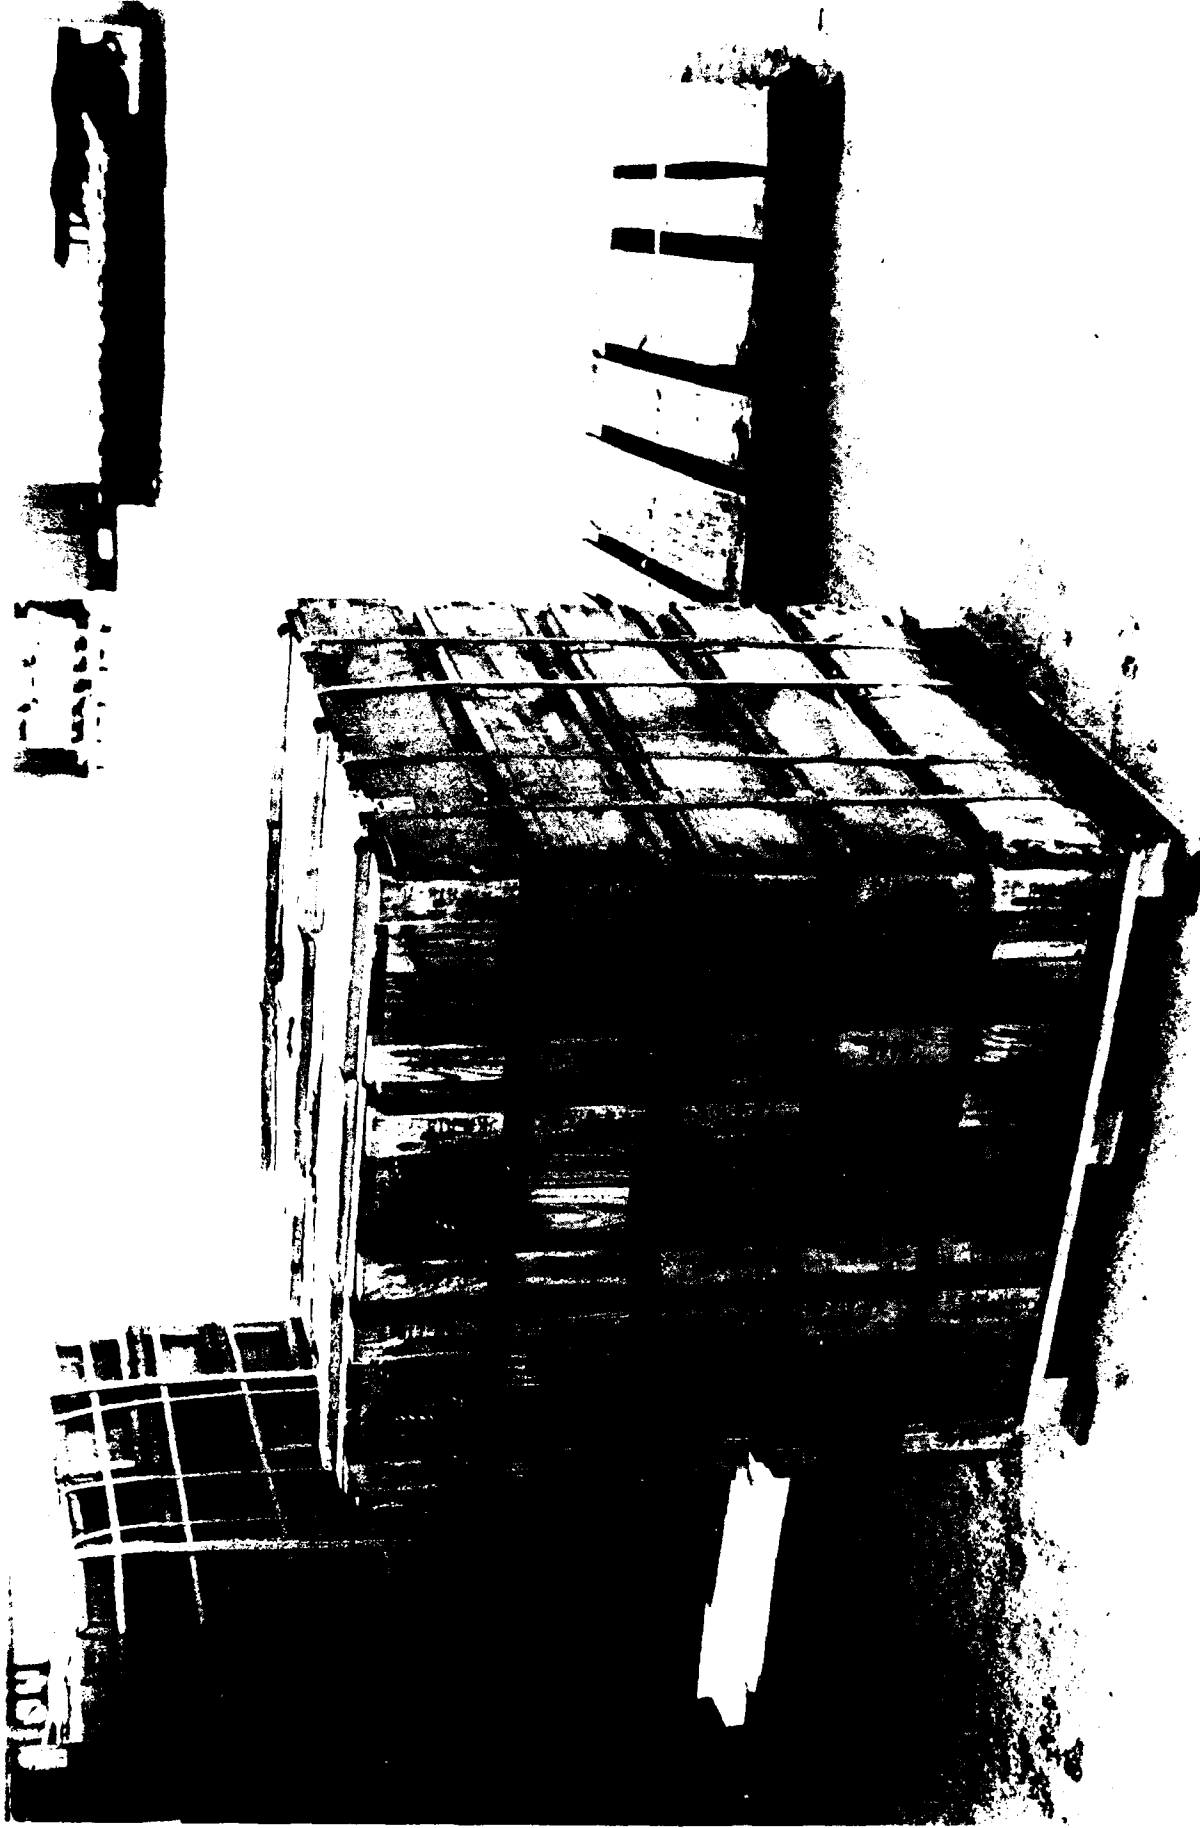
A. Test Pallet Containing Wood Boxes. Tests started at a 60 degree angle with the pallet being lifted approximately two feet off the ground. The first 30 seconds of each lift, the crane was oscillated, causing a jerking motion on the chain which increased the pressure exerted to the top of the pallet at points of contact with the chain. Following this procedure, the pallet was suspended in mid-air for a period of an additional 90 seconds, allowing the chains to dig into the sides of the containers. This procedure was followed for all lifts to simulate rough material handling of the pallets by the crane operator. Lifts from 60 down to 45 degrees showed no container damage with the exception of 1/4 inch imbedment of the chain at contact points. The tests continued down to 30 degrees with the boxes being inspected after each lift to determine serviceability of the containers. Each lift after 45 degrees showed minor increases in the container damage. The test was stopped after the 30 degree lift with the boxes still serviceable. The side walls supporting the hinges were extended inward approximately 3/8 inch with the hinges and wooden lid still operable and serviceable. The contents within the boxes (inert fill) showed no signs of spillage. Photo 1 page 8-1 shows damage to the wooden box after the final lift. A second series of tests were conducted with the pallet rotated 90 degrees. With the chains contacting the ends of the wooden boxes, embedment of the chains into the end grain of the wood was noted, as well as chipping of the wood at points of contact, photo 2 page 8-2.

Photo 1 Page 8-1 - Shows pallet containing wooden boxes after the final 25 degree vertical lift, with the chains positioned along the longitudinal side of the boxes. Minor damage can be noted at chain contact points on the top layer outside edge, with wood chipping, chain embedment and hinge slightly deformed. The box was still structurally sound and serviceable.

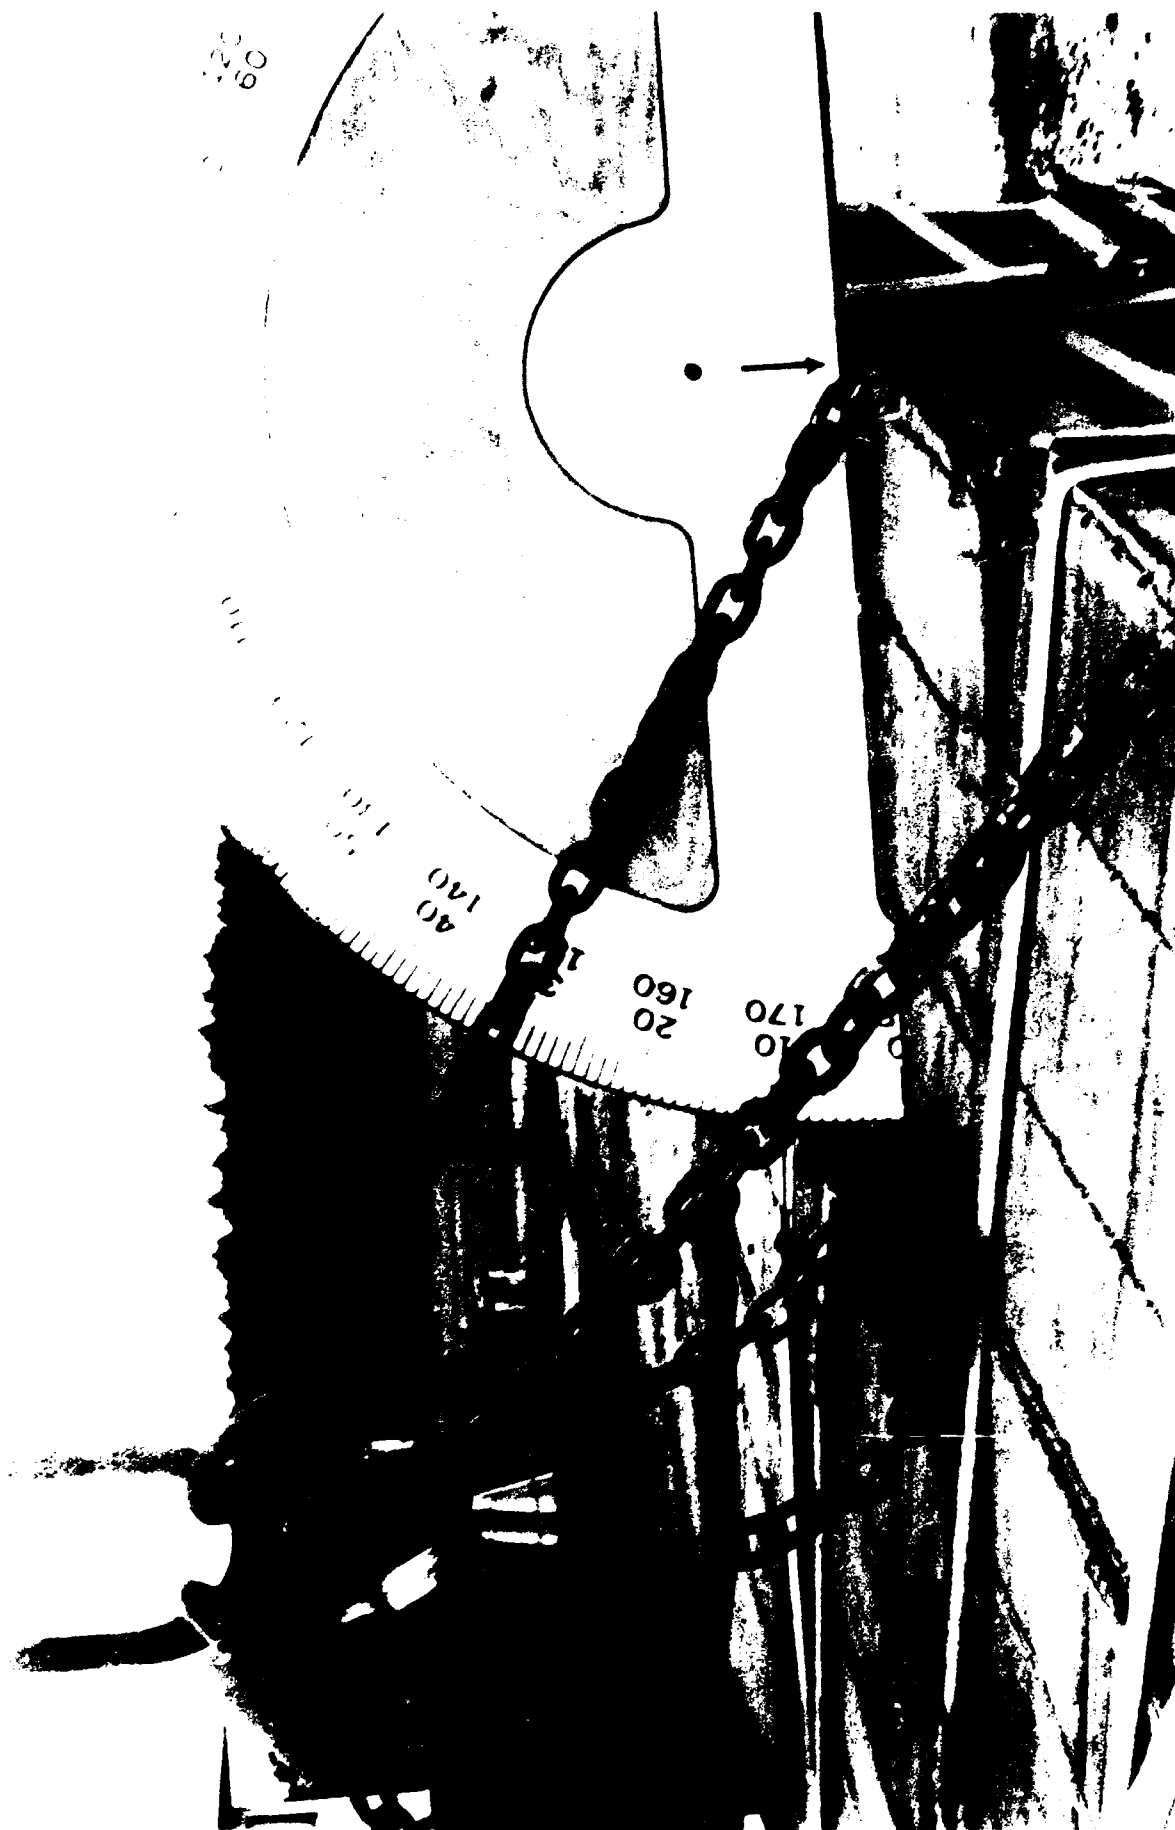
60 degrees to 45 degrees, no physical damage was noted. At 30 degrees, photo 3 shows the boxes misaligned where contact with the chains was being made, as well as digging into the edge of the wire bound boxes. The chains were also digging into and collapsing the fiberboard pallet used for this test (Photograph 4), which caused functional damage to the pallet as well as wire bound boxes directly above points of failure of the pallet. Inspection after the final lift (25 degrees) indicated that all wire bound boxes at the top of the pallet (area of interest for this test) were still serviceable having minor wood chipping, with the contents not damaged and repalletization not necessary prior to future handling.

Photo 3 Page B-3 - Shows the pallet containing winch and boxes to be lifted. Measurements of the boxes and minor chipping of the winch can be noted at pressure points with the chain.

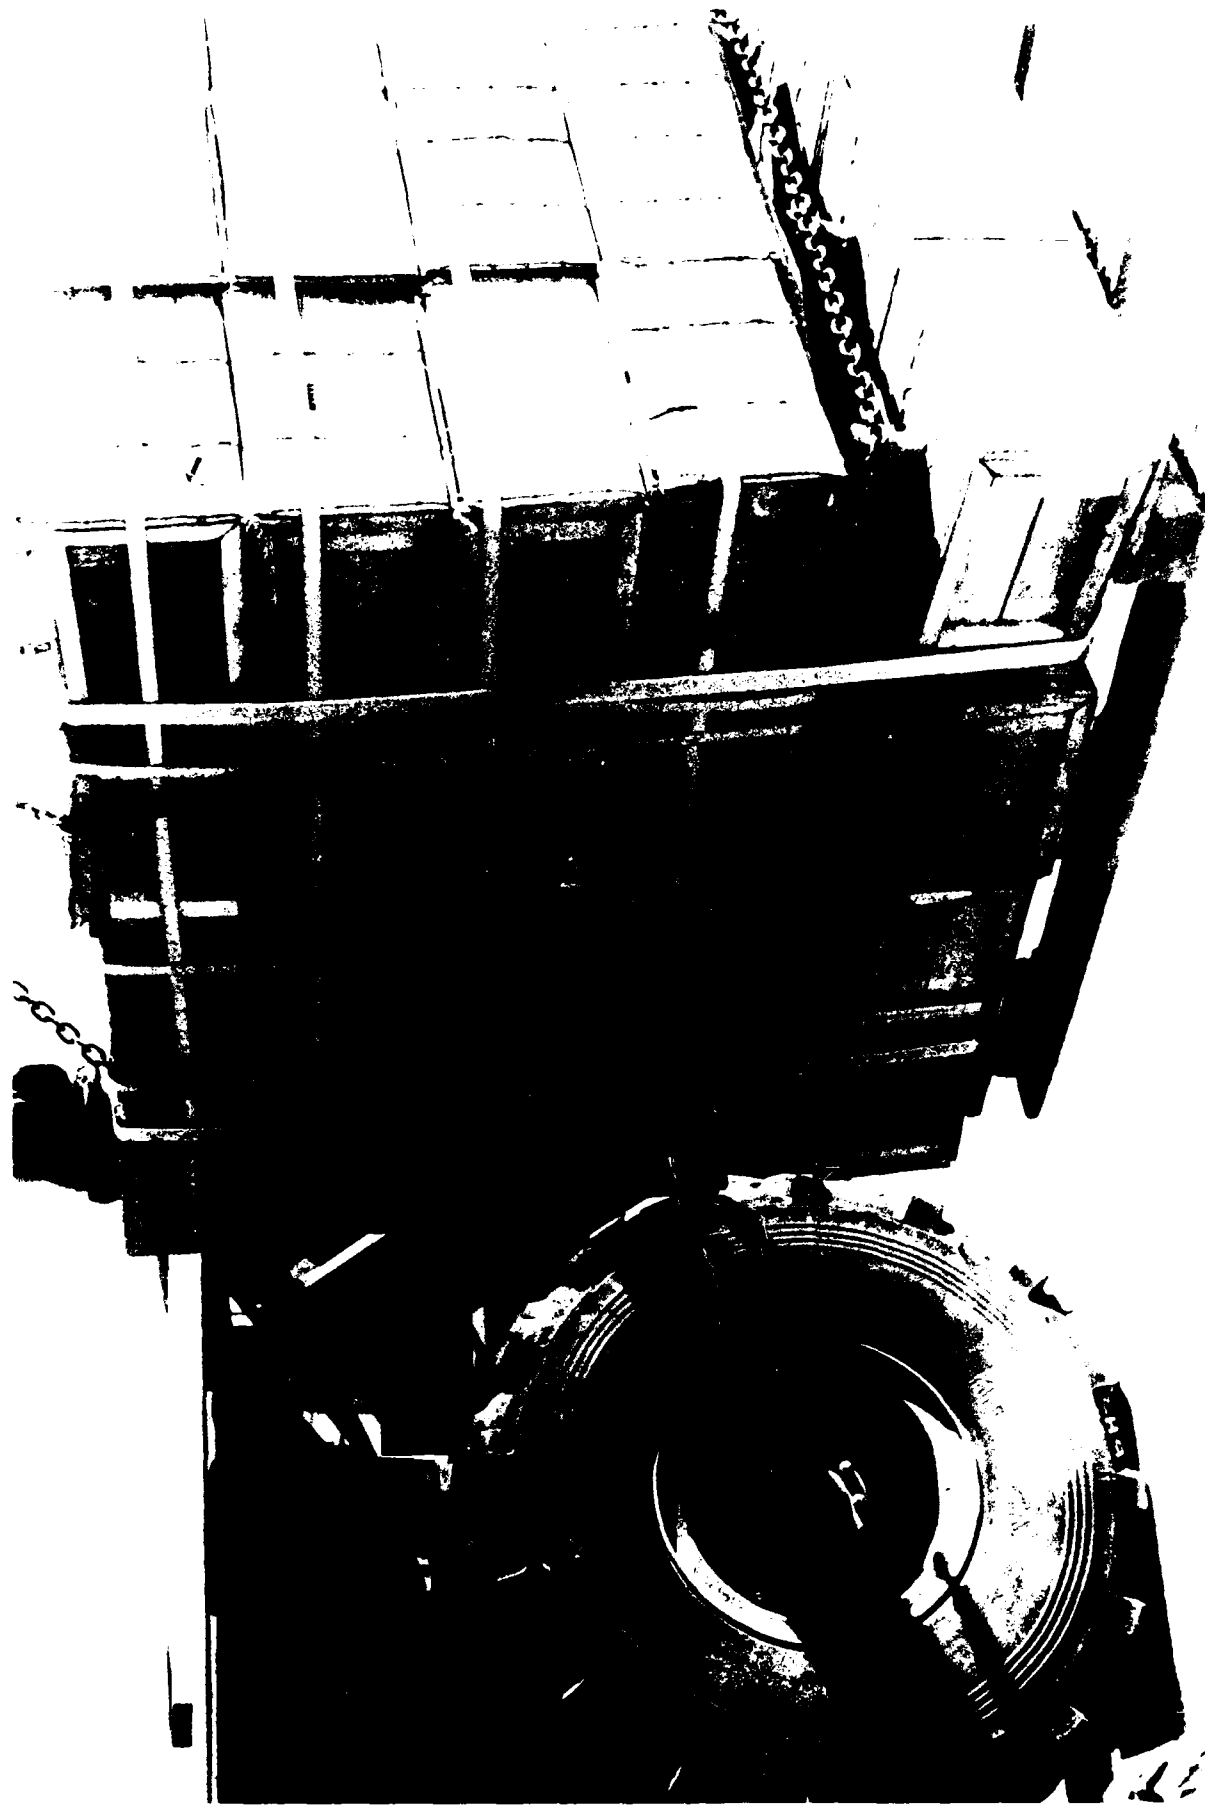
E. Structural and functional damage was noted to containers during two tests: 1) wire bound boxes with a fiberboard pallet during sling angle tests, and 2) wooden boxes with a wooden pallet during wall impact tests. In both cases, container damage was caused by pallet failure and/or excessive impact forces, not the chain sling angle or spreader bars, which was of interest during the tests.

Photo 4 Page 8-4 - Same pallet seen in Photo 3 from the side, showing the structural damage to the pallet at lift points of the basket sling. Also note the cover slightly raised at the top of the pallet caused the lid being caught on a chain link as the pallet was vertically lifted, with no structural or functional damage occurring to the top of the pallet. A single layer pallet was added to the base of the test pallet to achieve the proper test weight.
